# **Nissen Reservoir Channel** *Ecological Site Assessment*

**BROOMFIELD COUNTY, COLORADO**

**DHM DESIGN**

**October  
2017**

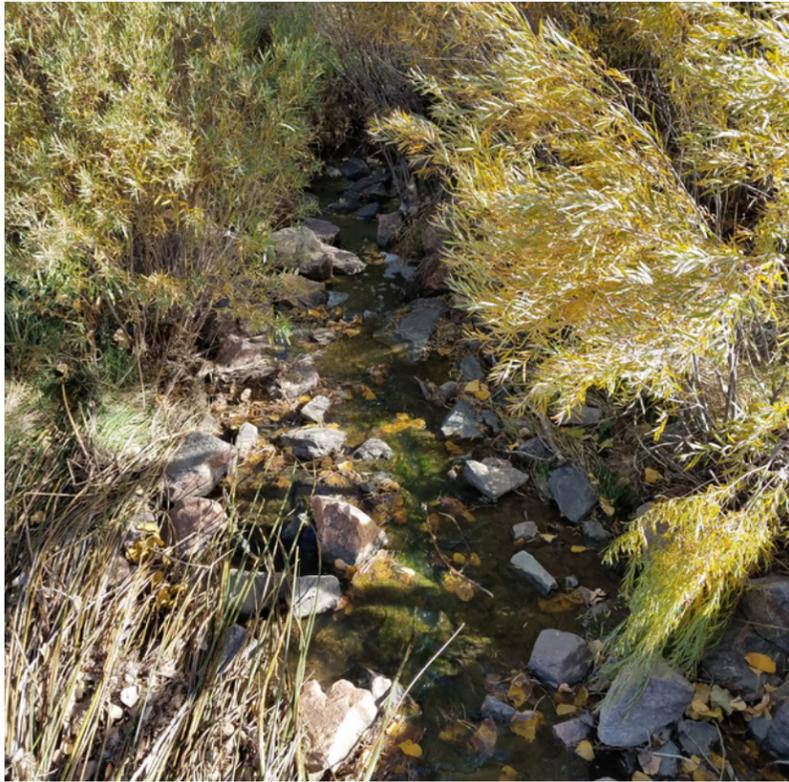
**Image 1** Looking southeast at the stream channel in moderately functioning section 1. Algae is covering the rocks in the stream. Coyote willow, showy milkweed, and soft-stem bulrush are present.

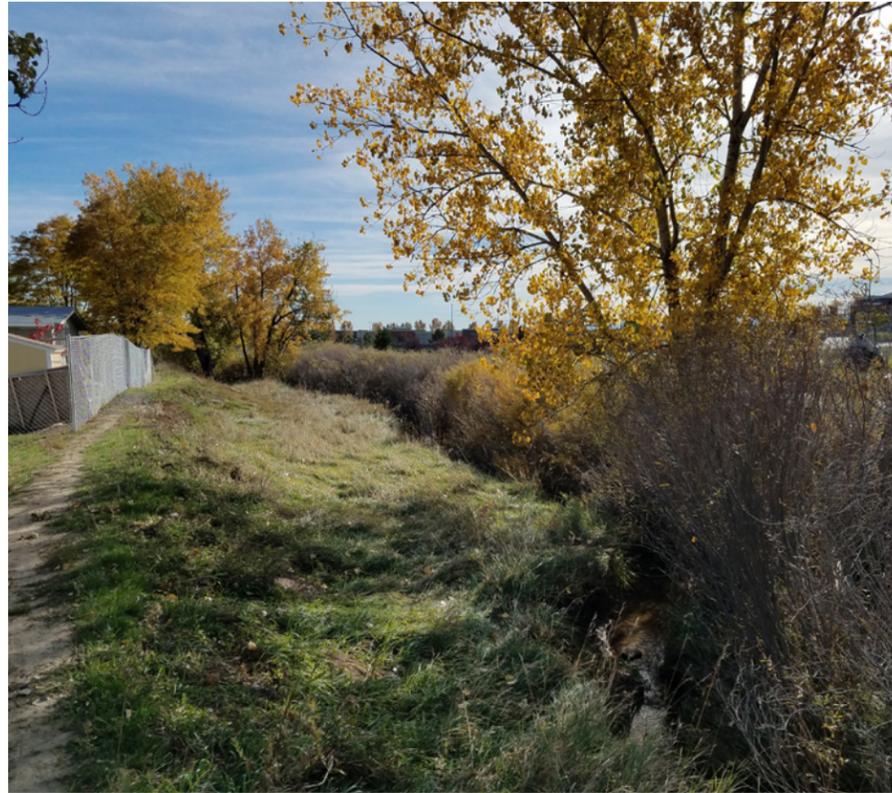
**Image 2** Looking south at the riparian corridor of moderately functioning section 1. Coyote willows line the west (right) bank which rises steeply to a turfgrass park and a walkway. Smooth brome and western wheatgrass are the dominant grass species on the east (left).

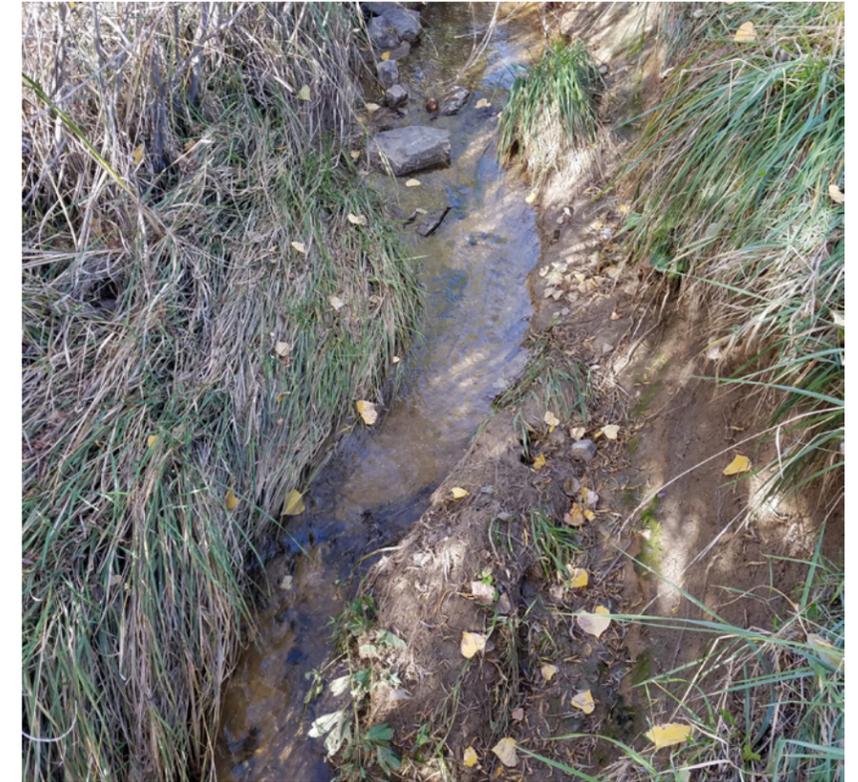
**Image 3** Looking down and north at the narrow stream channel in section 1.

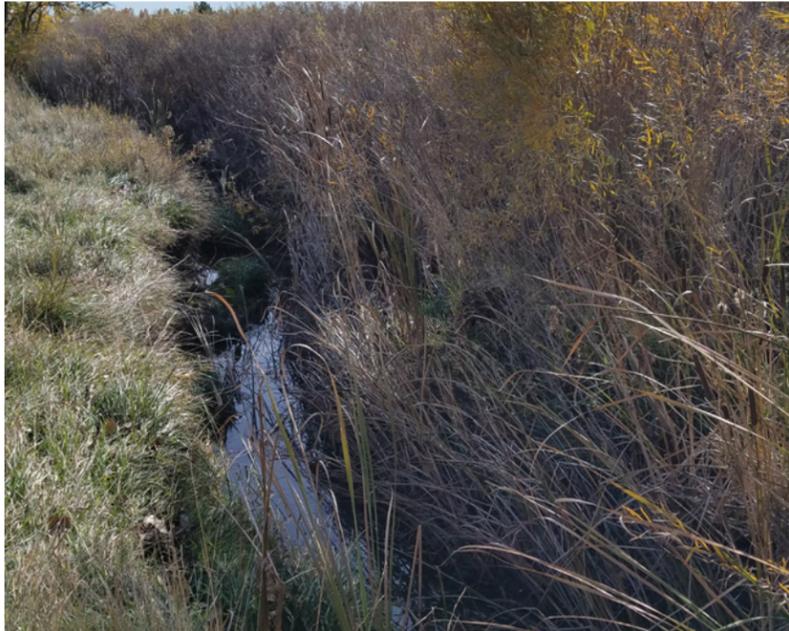
**Image 4** Looking south at the riparian corridor in section 1.. Cattails are present in the channel.

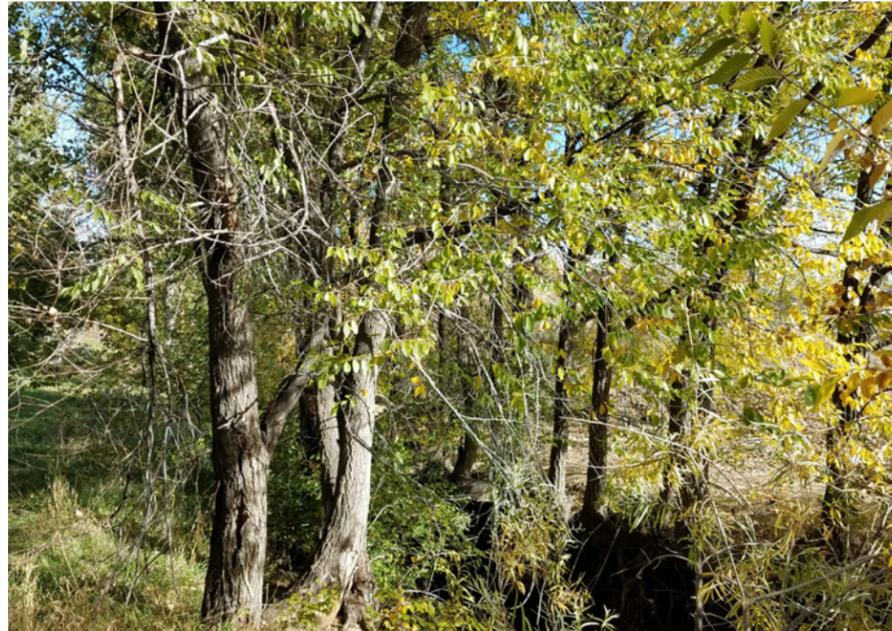
**Image 5** Looking east at a patch of Siberian elms in low functioning section 2. The high percentage of non-native vegetation is a major issue for this section.

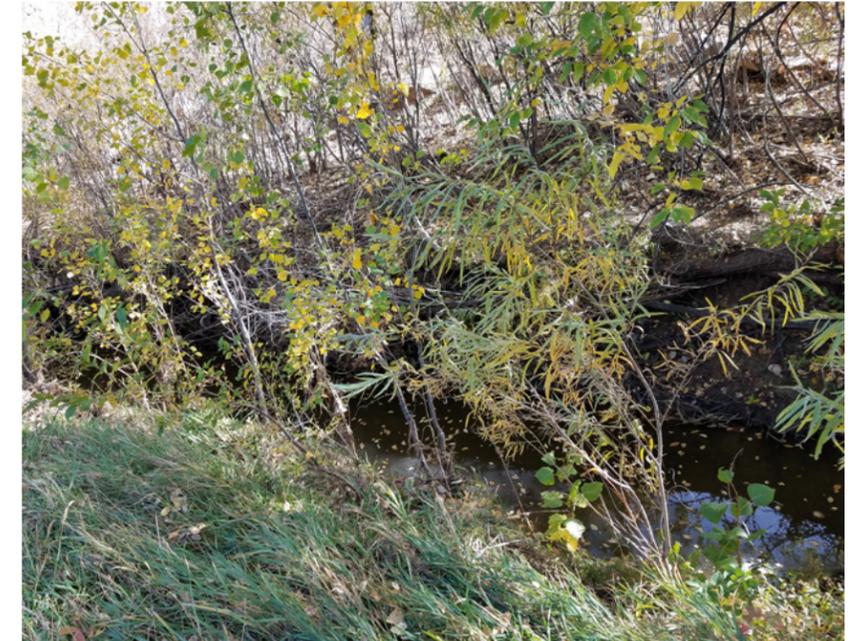
**Image 6** Looking southeast in low functioning section 2 at an area that has plains cottonwoods saplings. The north (left) bank has an understory of grasses and the south (right) bank is lacking understory below coyote willows and is unstable.

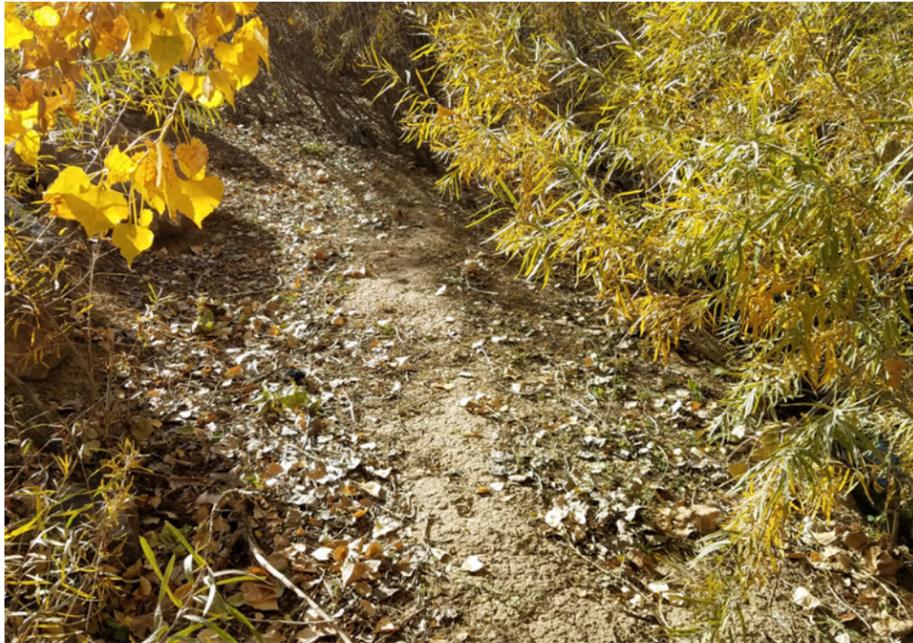
Section two is located immediately downstream (east) and adjacent to section 1. This section is considered to be functioning at a low level due to its high degree of channelization, eroding banks, high prevalence of noxious vegetation, and lack of floodplain connecting it to upland (Appendix B, Image 8). The south side riparian corridor of this section is mostly lacking vegetation due to its steep bank that leads directly to upland (Appendix B, Images 6 and 9). Noxious and non-native vegetation including Common teasel, musk thistle, sweet clover, and plantain are present in high density on the south side of the stream channel. The north side of the stream channel in this section has a less abrupt transition to upland but the understory is dominated by noxious and non-native vegetation including common teasel, common mallow, plantains, and field bindweed. The north side of the riparian corridor includes plains and narrowleaf cottonwoods, with one patch of Siberian elms (Appendix B, Image 5). A potential wildlife game trail was observed on the south side of this section (Appendix B, Image 7).

**Image 7** Looking west at a potential game trail in section 2.

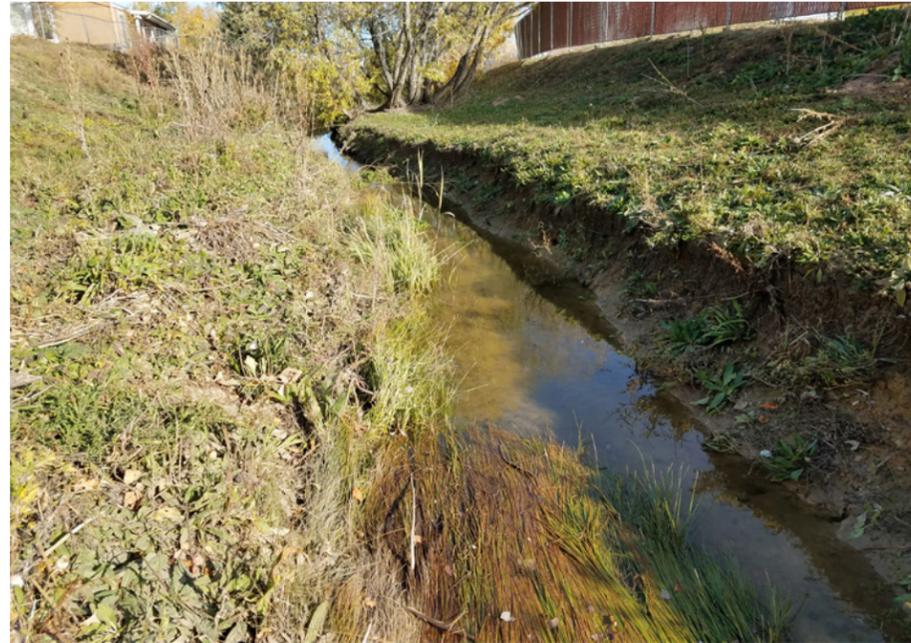
A positive observed in this section is the presence of aquatic vegetation including more soft-stem bulrush than other reaches. Bittercress, cattails, and another rush were also observed (Images 8 and 8.1).

**Image 8** Looking east at the corridor in section 2. The channel is incised and lacking connection to a floodplain which is another major issue in this low quality section. A high percentage of non-native vegetation is present both sides. Erosion is evident from the unstable bank on the south (right) side.

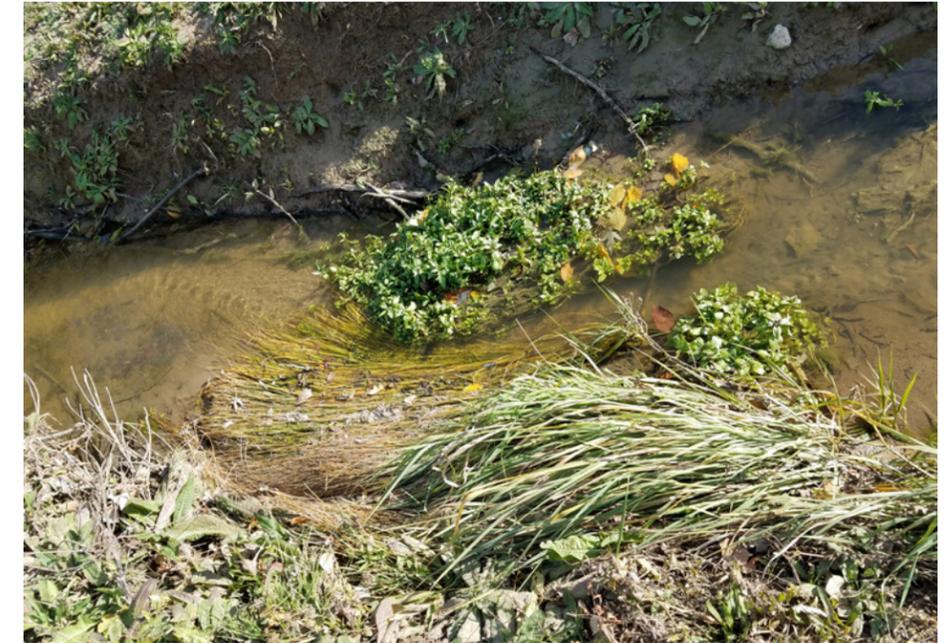
**Image 8.1** Looking down at bittercress and rushes in section 2. The bank on the south (top of picture) has a high percentage of bare soil and is unstable.

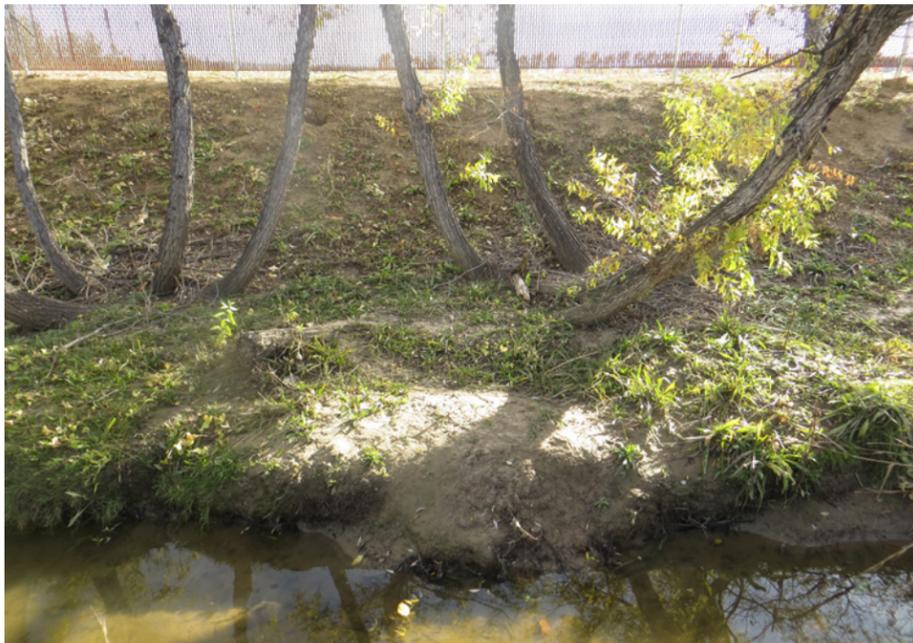
**Image 9** Looking south at narrowleaf cottonwoods in section 2 with an understory of bare soil and non-native plantain.

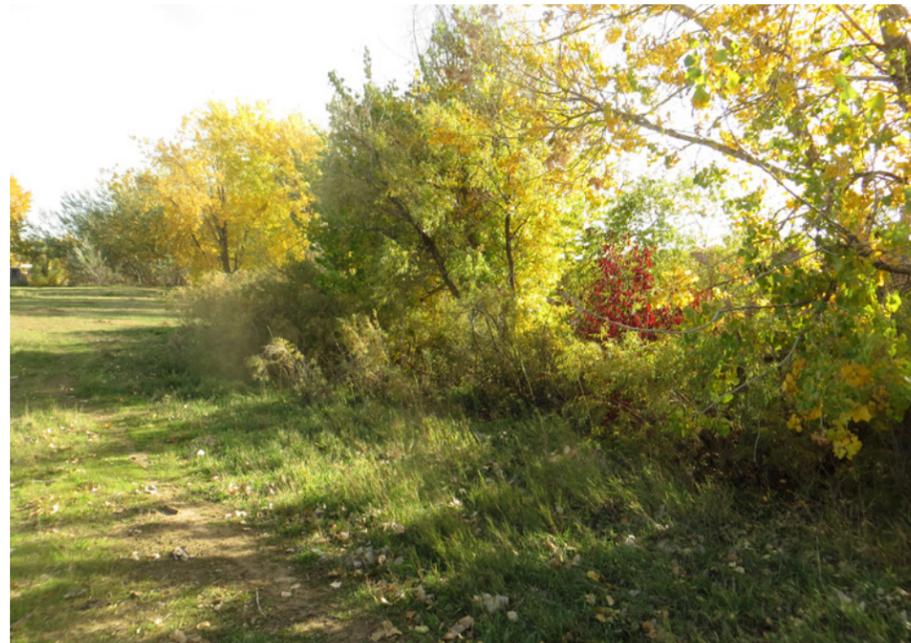
**Image 10** Looking southeast at moderately functioning section 3 that has better diversity in both the overstory and understory. A floodplain is present on the north (left) side of this reach.

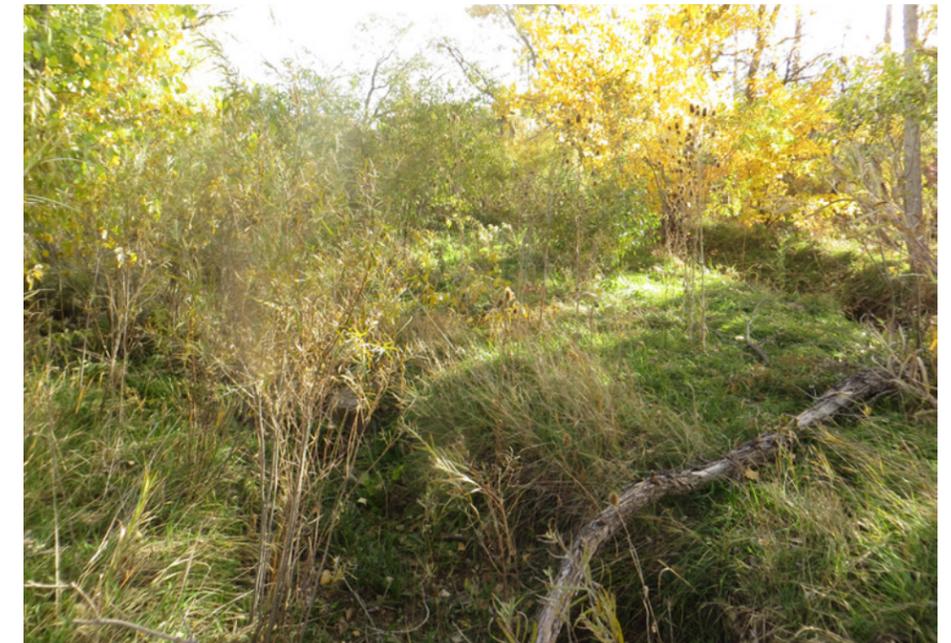
**Image 11** Looking southeast within the riparian corridor in section 3. It is wider, with multiple channels that could fill at high water levels. More wildlife habitat is present within this wider corridor, however it is still bounded by urban development on both sides which may deter use by larger animals.

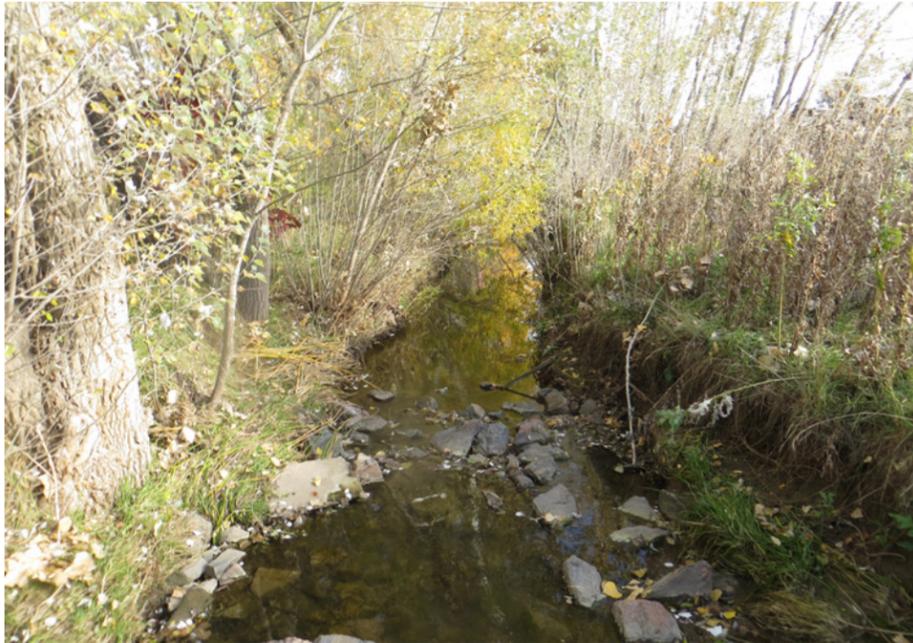
There are 3 concrete drop structures in this section with rock armoring downstream of them and to the north of the structures that are designed to divert water into the stream without causing gullyng (Appendix B, Images 12, 14, and 15).

**Image 12** Looking southeast while standing on a concrete structure in the channel in section 3. The channel widens after these structures and has a rockier bottom.

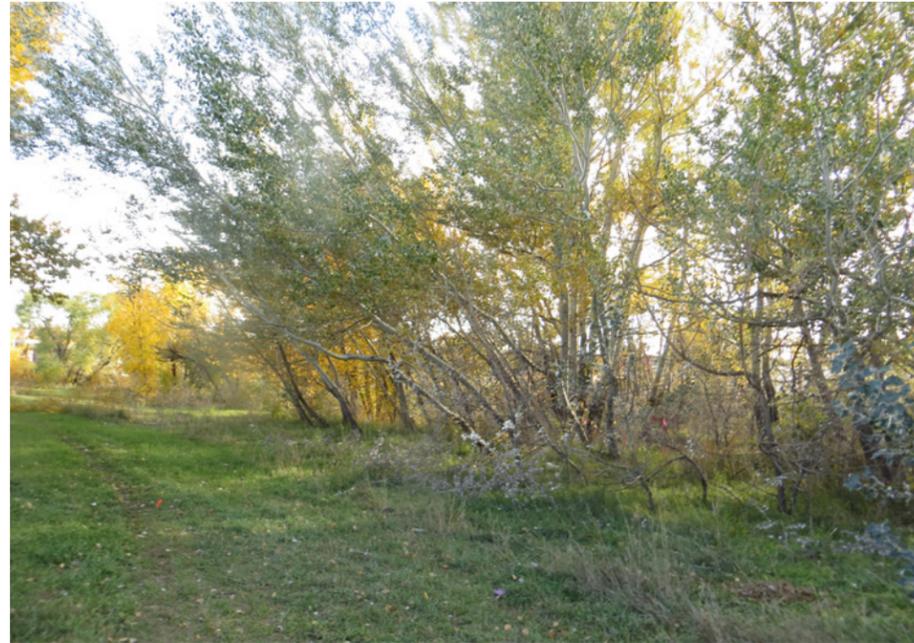
**Image 13** Looking southeast in section 3 at a stand of silver poplars and a well connected floodplain.

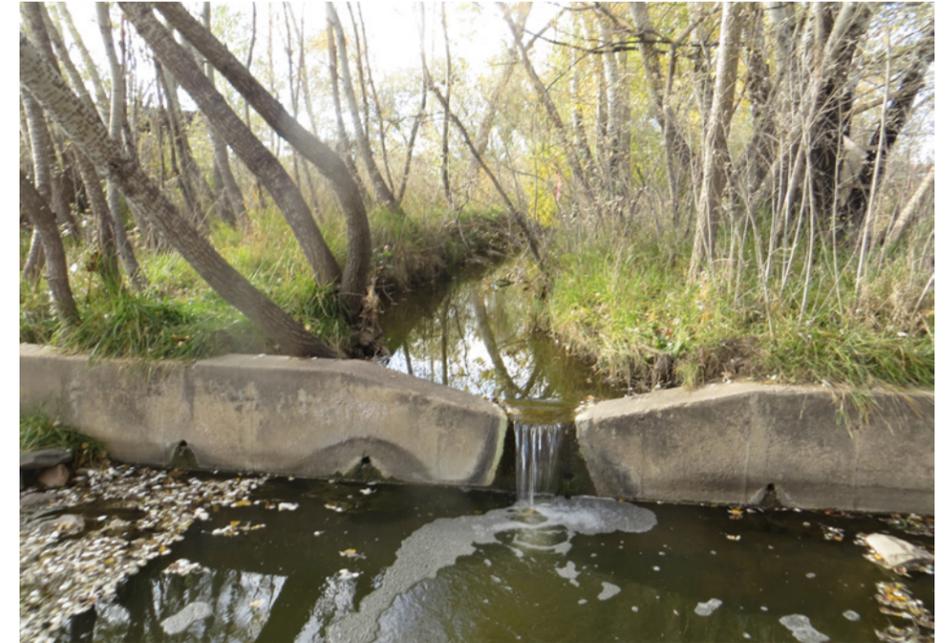
**Image 14** Looking northwest at the middle of three concrete drop structures in section 3. This is in the stand of silver poplars and a dense understory of native and non-native grasses is present.

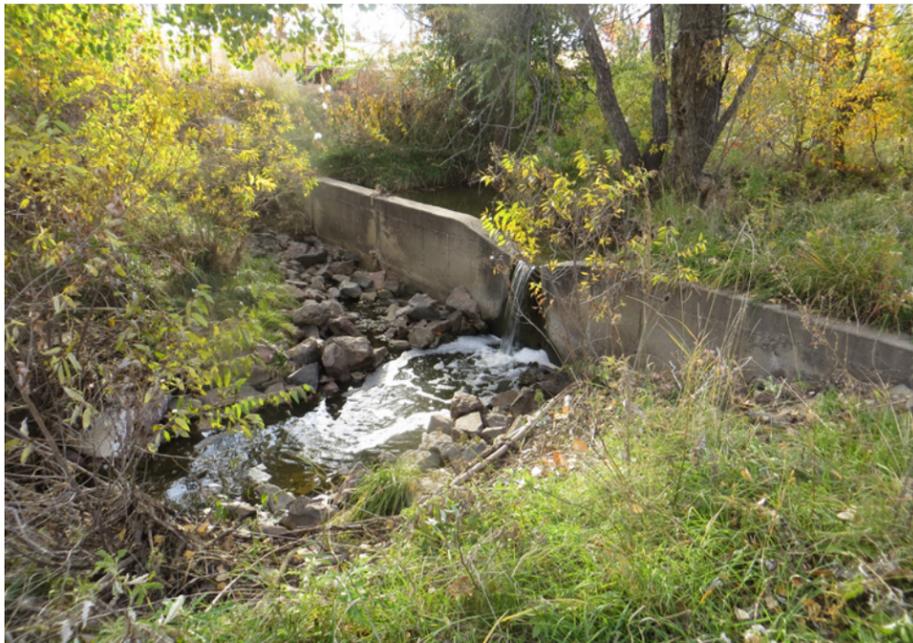
**Image 15** Looking southwest at a concrete drop structure in section 3. Despite the presence of these man-made structures, this section is moderately functioning with more natural meanders, riffles, and better connectivity to a wider floodplain. This section also has the most diversity in the overstory and understory. It is bound by urban development on both sides of the riparian corridor.

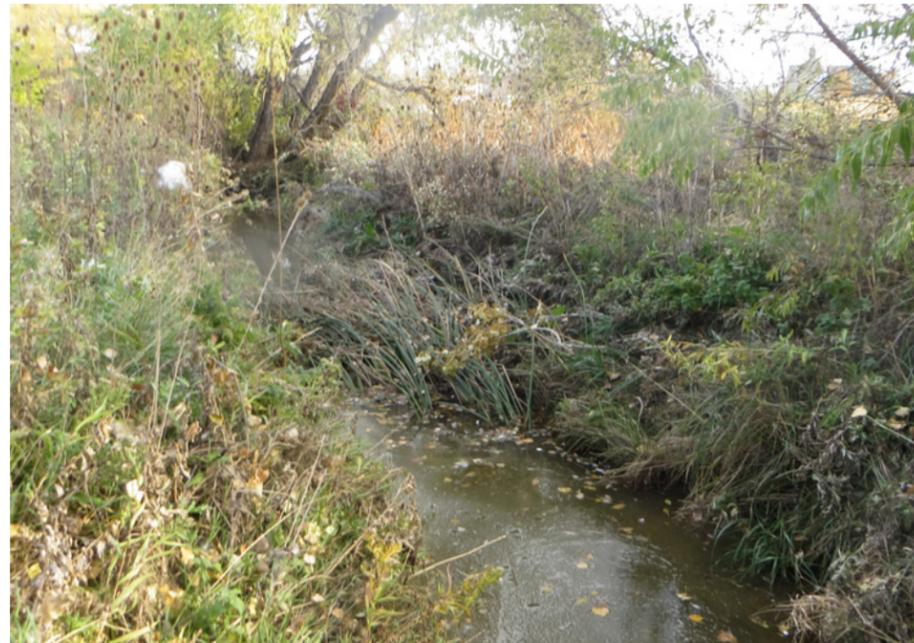
**Image 16** Looking southeast at a stretch of slow moving water in section 3 with an incised channel. Diverse vegetation is present in this section.

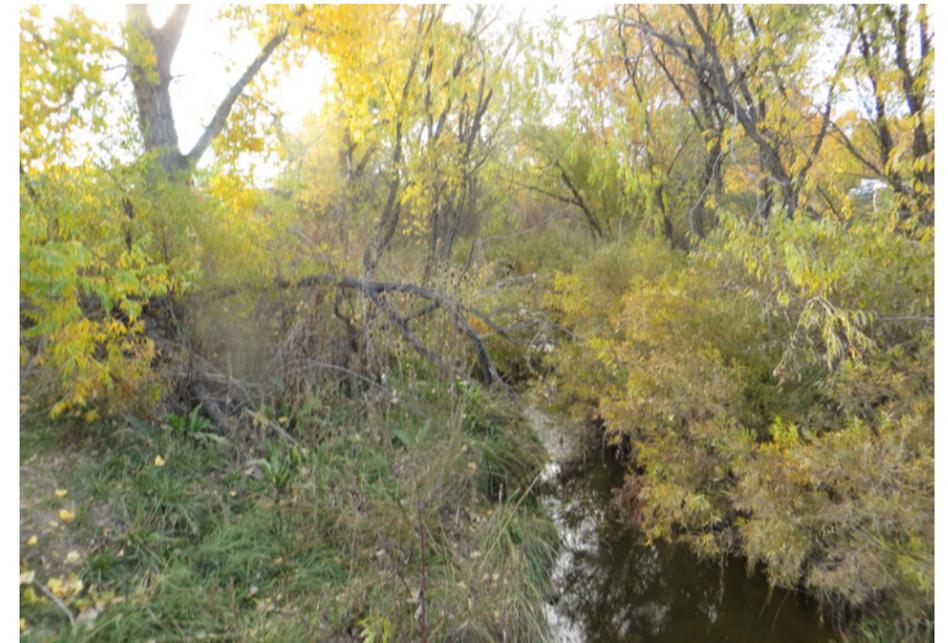
**Image 17** Looking west at the dense riparian vegetation in section 3 from the culvert at Perry St.

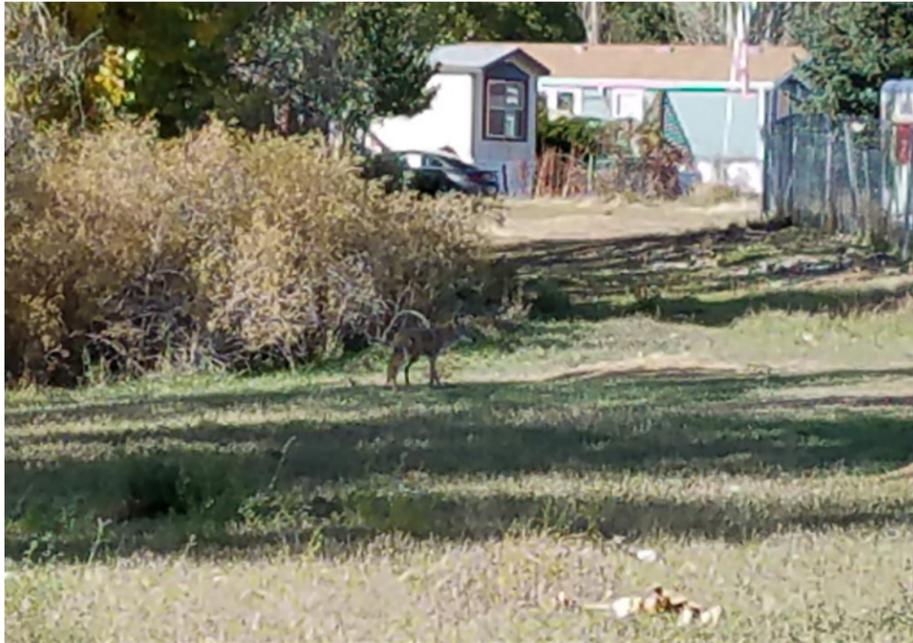
**Image 18** Looking northwest at a coyote near prairie dog holes in section 3.

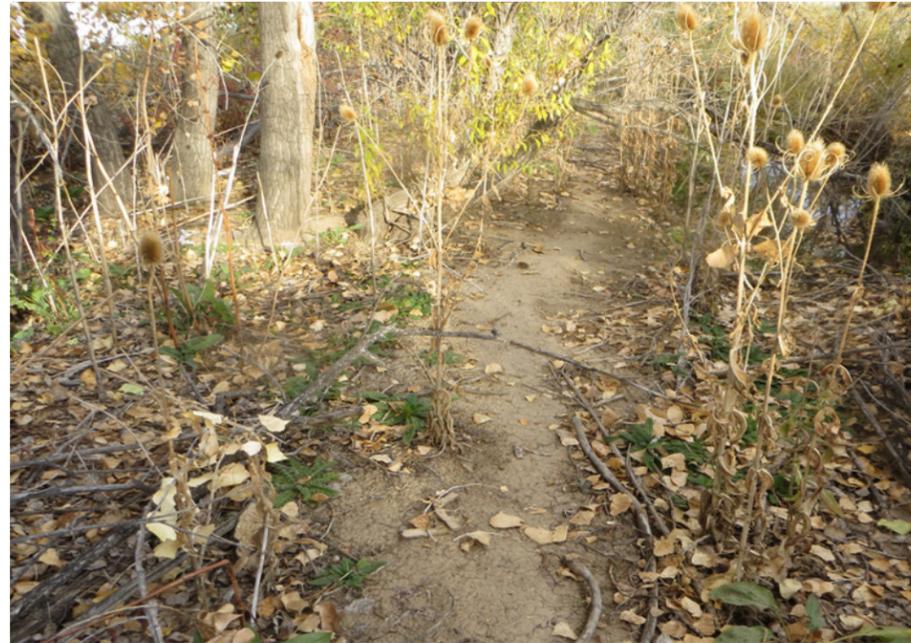
Two nests were observed in this section and a game path was observed on the north side of the channel (Images 19 and 20). Near Perry St. is a dense stand of coyote willow that would provide good cover habitat.

**Image 19** Looking east at a potential game trail in low functioning section 4. The understory, which consists of bare soil or organic matter and common teasel, is also in view. This section has a high percentage of non-native vegetation.

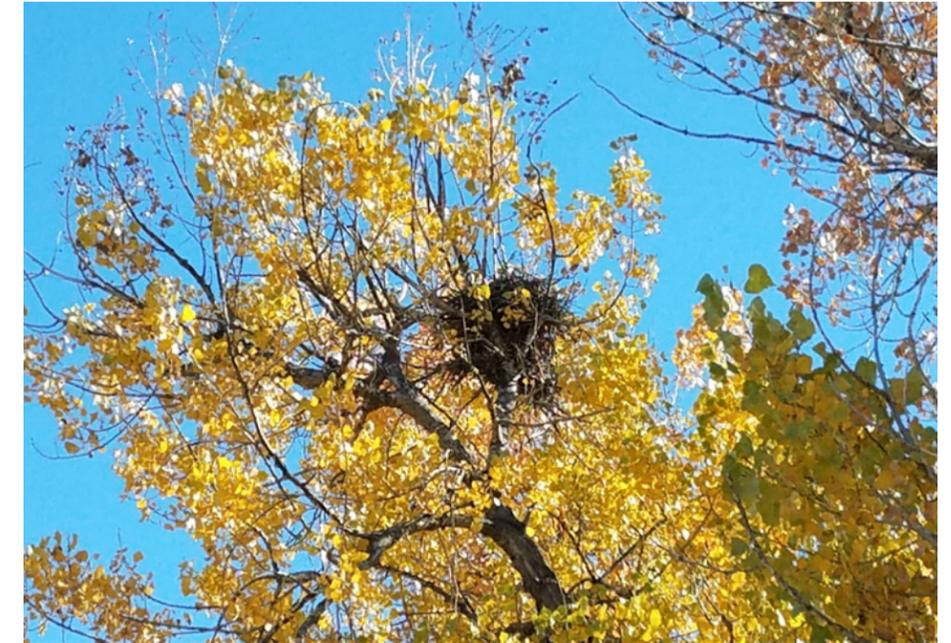
**Image 20** Looking up at a potential raptor nest in a plains cottonwood.

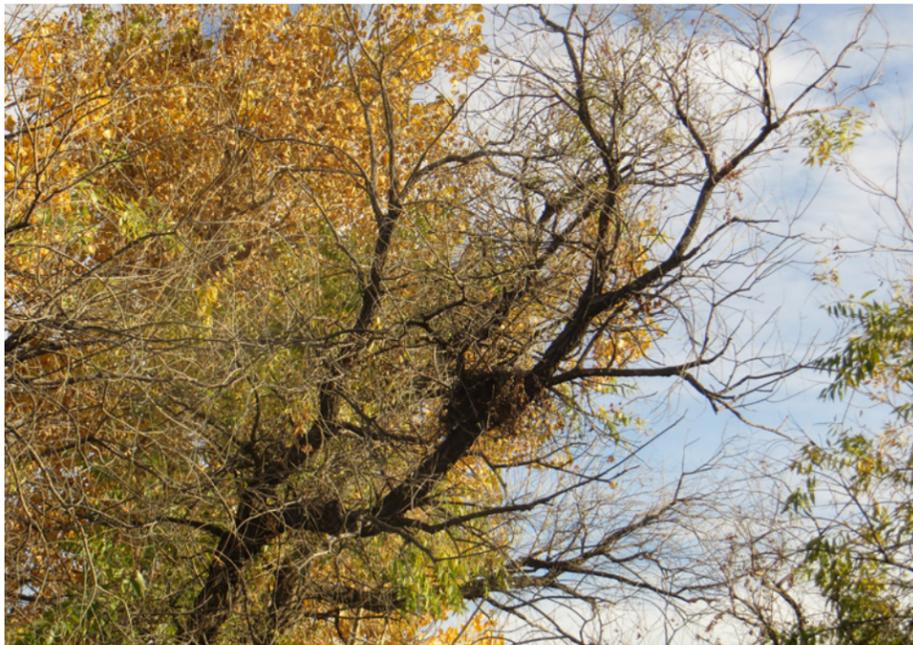
**Image 20.1** Looking up at a second potential raptor nest in section 4 near image 20.

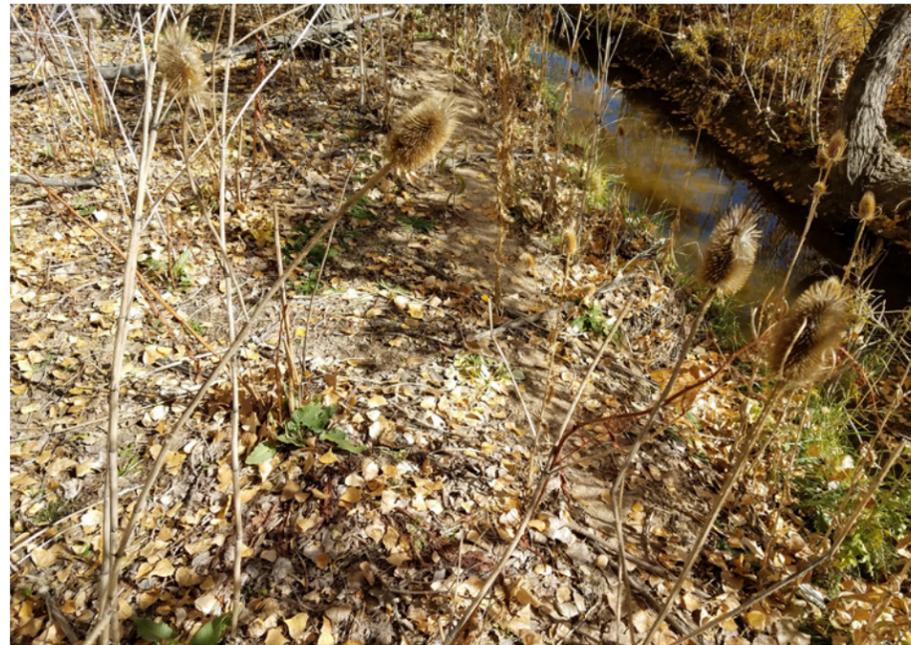
**Image 21** Looking east at the understory in section 4 which is lacking native vegetation. Much of this section has common teasel, Canada thistle, and other non-native species in its understory.

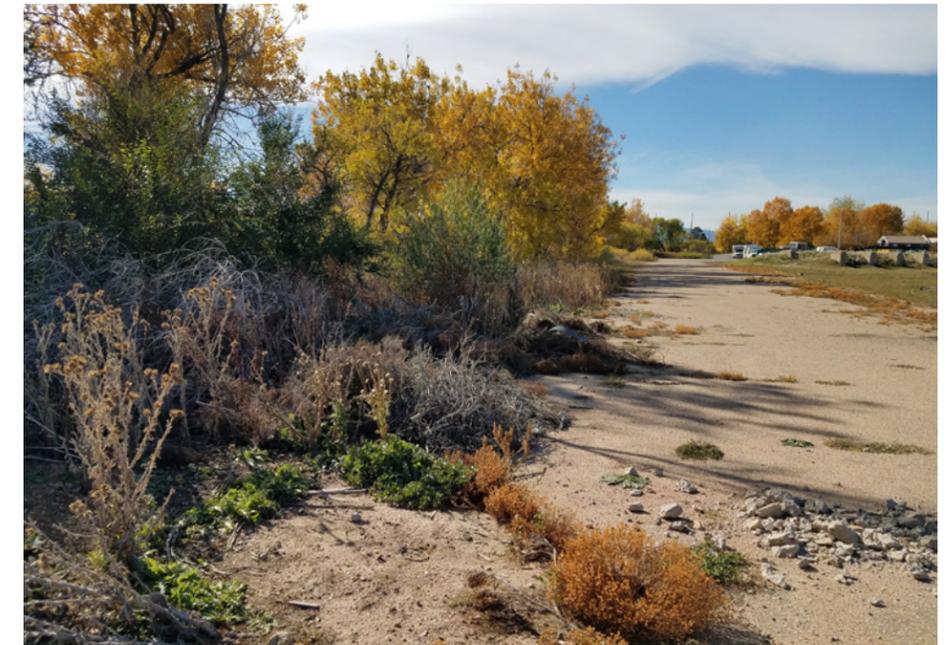
**Image 22** Looking west at low functioning section 4. The overstory has many healthy plains cottonwoods, but Siberian elm and Russian olive are also present. The channel is straightened in this section and much of the understory is dominated by non-native vegetation. The north side of the corridor is bounded by concrete with a prairie dog colony north (right) of the concrete.

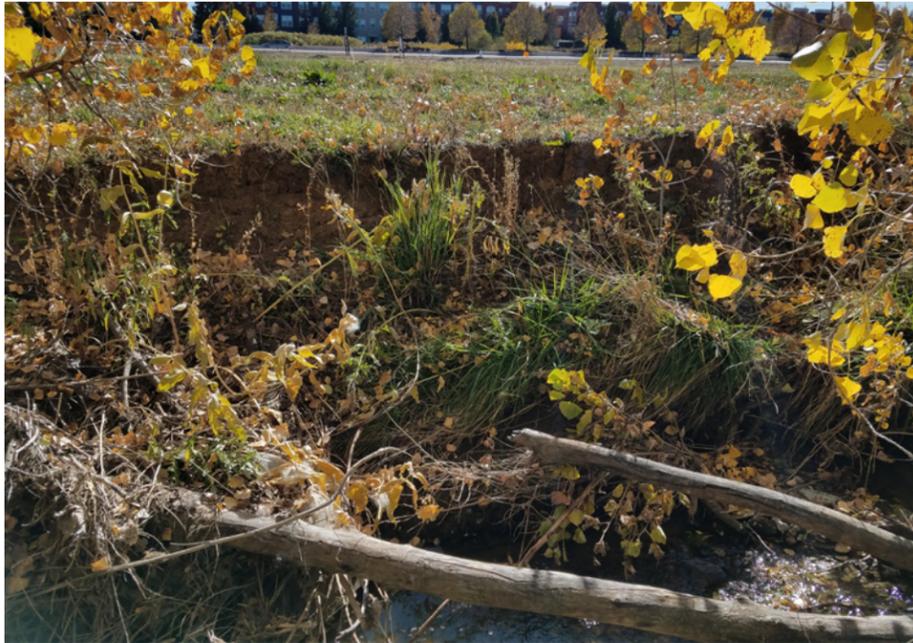
The south side of the channel has very little riparian area and abruptly transitions from stream channel to upland (Appendix B, Images 23 and 24). Bank erosion and exposed roots are present throughout this section on both sides of the stream channel. There is less noxious vegetation on the south side. A row of coyote willows provides the majority of vegetation on the south side of this reach with little understory. There is a healthy stand of plains cottonwoods on the north side of the reach providing habitat for birds and cover small mammals (Appendix B, Images 24 and 26). However, most of the understory in this area consists of noxious vegetation, primarily common teasel and Canada thistle. Russian olives and Siberian elms are also present.

**Image 23** Looking south at the straightened, incised channel that rises abruptly to an upland in section 4. The bank is eroding and unstable. This is a main issue lowering the proper ecological function of section 4.

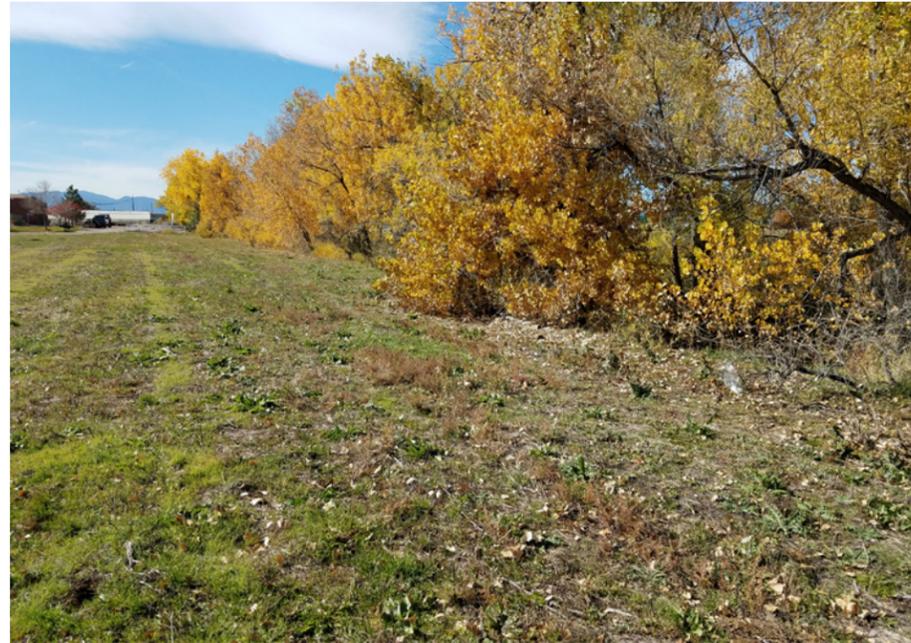
**Image 24** Looking west at the riparian corridor and upland in section 4 which shows a lack of floodplain on the south (left side). The lack of connection to a floodplain is an issue lowering the proper ecological function of section 4.

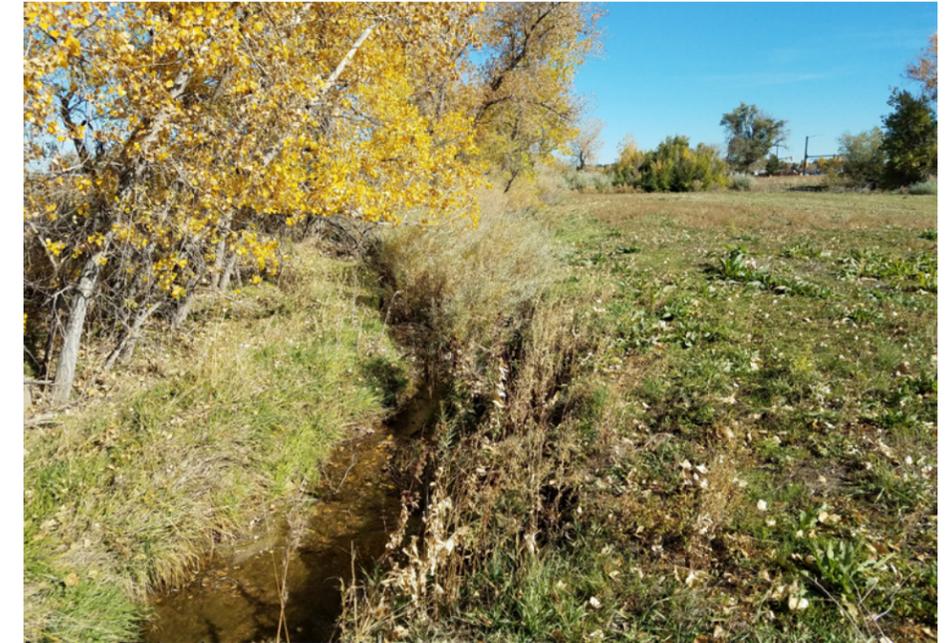
**Image 25** Looking east at the channel in section 4 which has cottonwoods and a small floodplain on the north (left) side, but a steep bank leading to upland on the south (right) side.

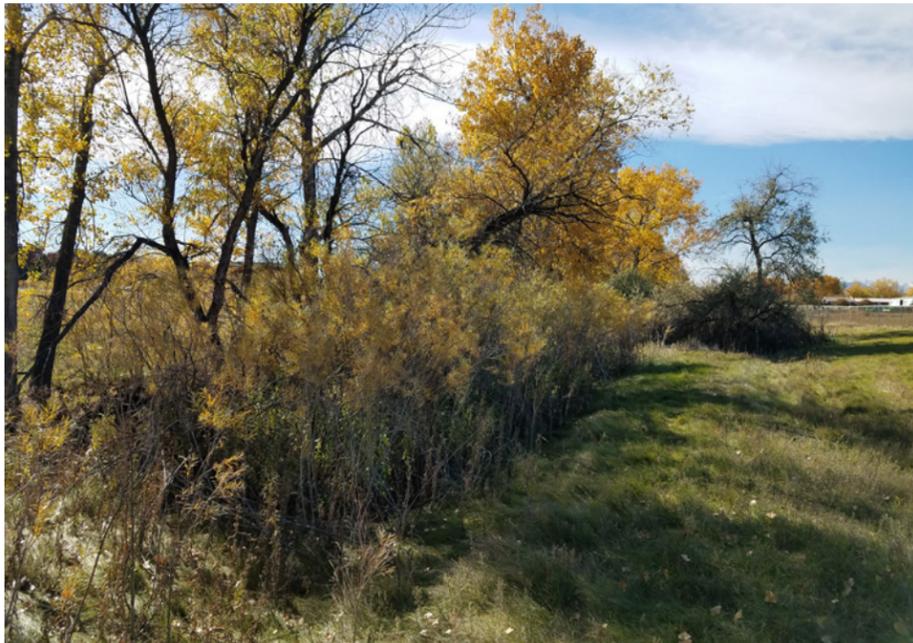
**Image 26** Looking west at coyote willows lining the riparian corridor in section 4.

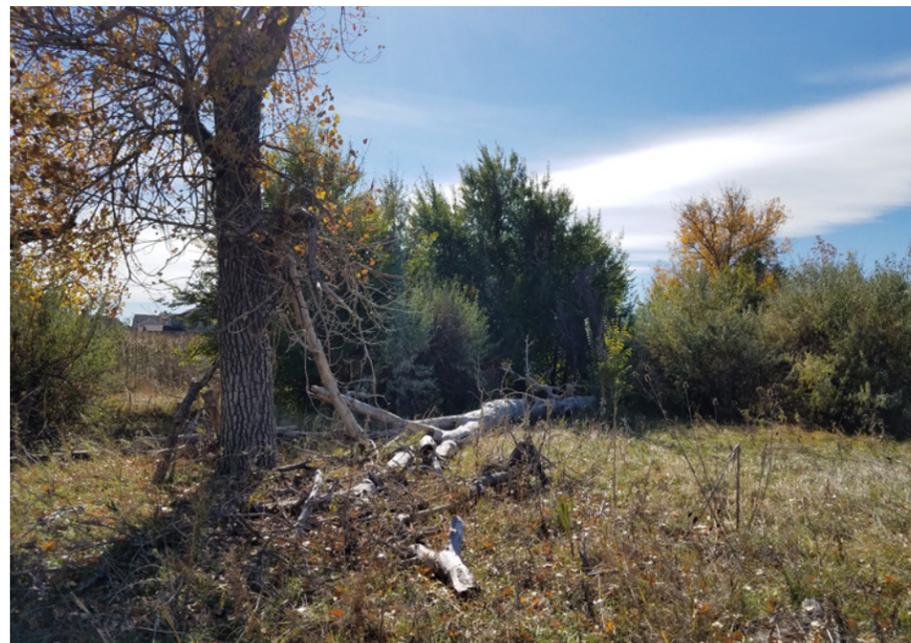
This section is located adjacent to and downstream (east) from section four. It is differentiated from section four to the east by a more meandering stream channel with sections of riffles and a lack of willows which are only present west of and near the confluence. There are some mature cottonwoods, including a downed cottonwood and a standing cottonwood that is dying (Appendix B, Image 27).

This reach does have a more Russian olives and Siberian elm than other reaches (Appendix B, Images 27 and 29). Siberian elms are dense near the confluence and are contributing to a lack of plant biodiversity, choking out the understory.

**Image 27** Looking southwest at a standing plains cottonwood that appeared unhealthy and a downed plains cottonwood in moderately functioning section 5. In the background are dense Siberian elm and coyote willow at the confluence of the Nissen Reservoir Channel and a side channel.

Russian olive, Siberian elm, and crack willow should be removed from the corridor using the cut-stump method of cutting the trees and applying herbicide to the cambium layer of the stump to prevent regrowth. After removal, follow up treatment will be necessary to remove seedlings that grow from seeds in the soil or transported onsite by birds, water and wind vectors.

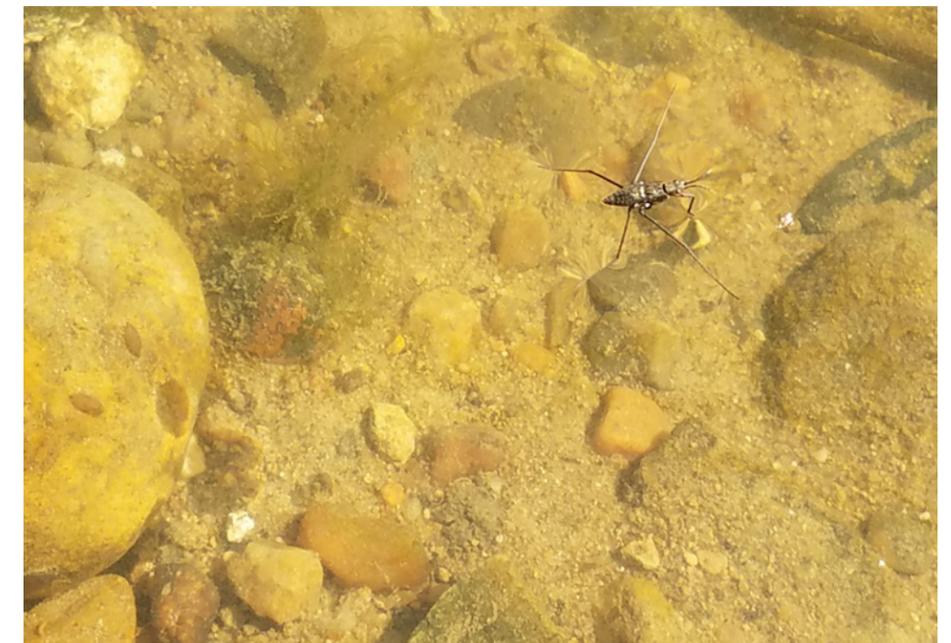
**Image 28** Looking down at a water strider in section 5. They were observed throughout the assessment area.

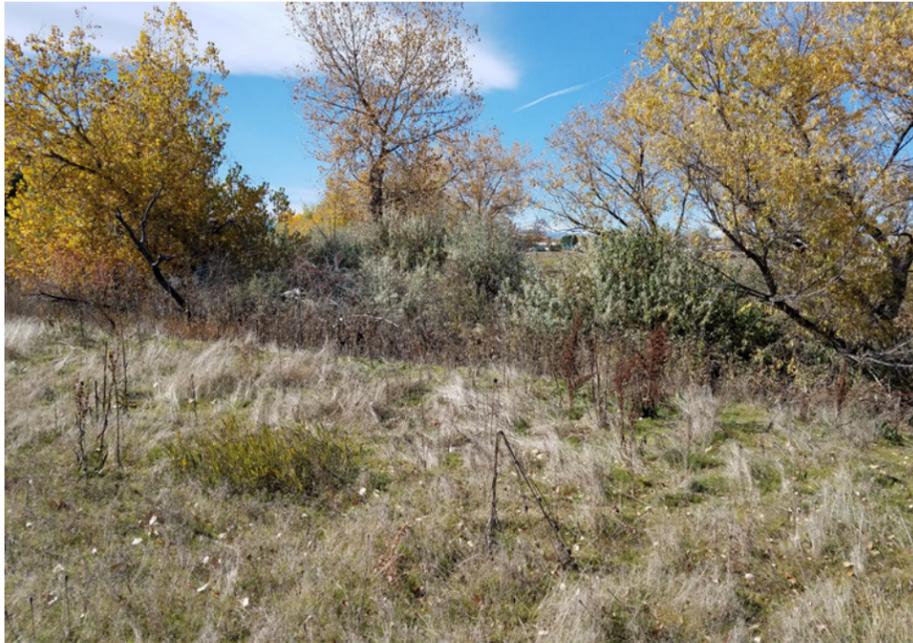
**Image 29** Looking northwest in section 5 at Russian olive while standing in dense cheatgrass.

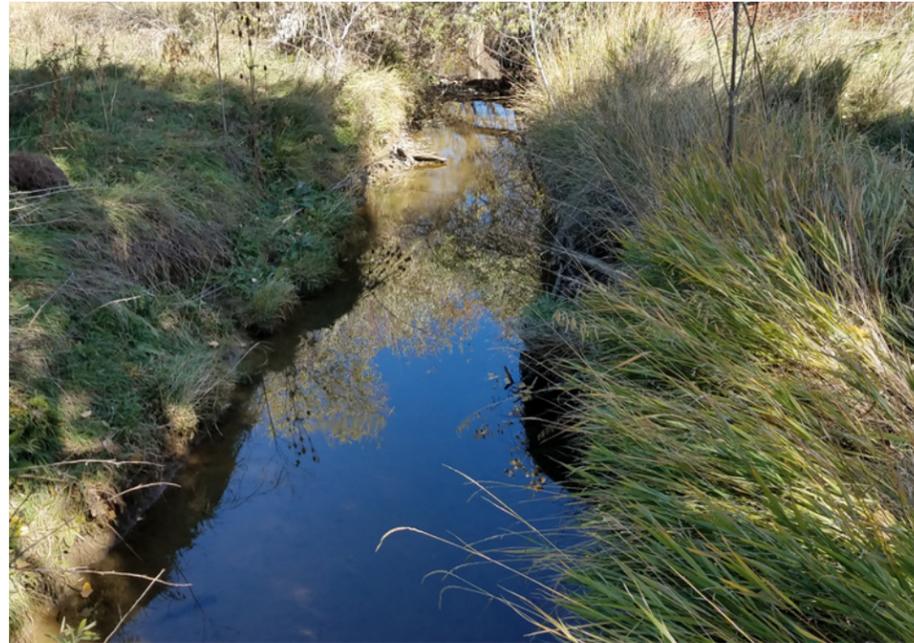
This section has moderate channel incision and connection to the floodplain (Appendix B, Image 30). The north side has a wider floodplain and more gradual connection to the upland with the understory dominated by smooth brome. The south side has a more abrupt transition to upland and has more noxious vegetation than the north side. Common teasel and Canada thistle are both dense in this transition zone and cheatgrass is dominant in the upland area which is home to a prairie dog colony (Appendix B, Image 30.1).

**Image 30** Looking northeast at the stream channel in section 5. It is somewhat incised, but highly vegetated on both sides.

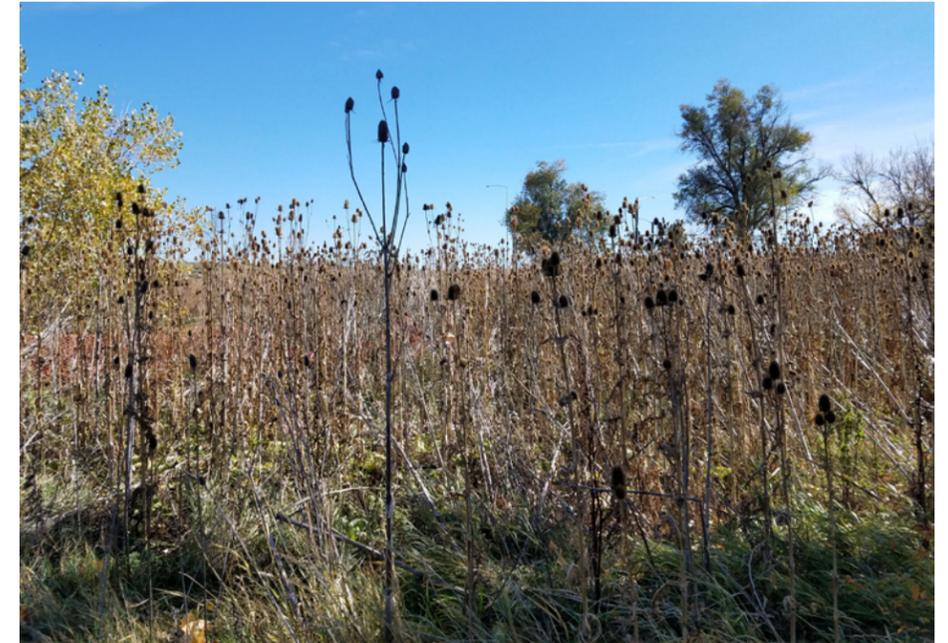
**Image 30.1** Looking southeast at a dense stand of common teasel in section 5. Overall there is not a high percentage of non-native vegetation, but it is dense where it was observed.

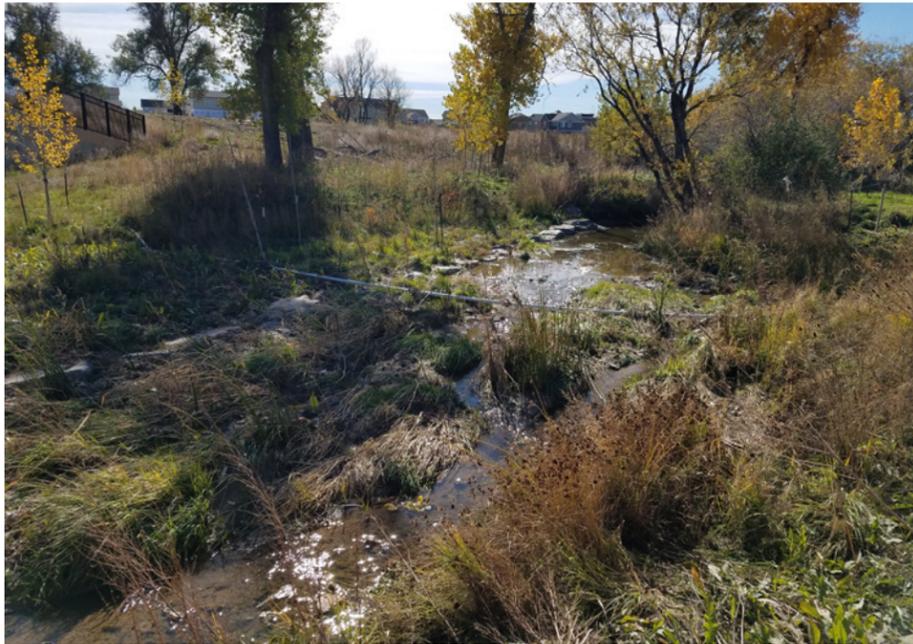
**Image 31** Looking southwest at the restored and moderately functioning section 6. This section has wetland planting and seeded grasses, but a high percentage of non-native vegetation is also present.
