# **Nissen Reservoir Channel** *Ecological Site Assessment*

**BROOMFIELD COUNTY, COLORADO**

**DHM DESIGN**

**October  
2017**

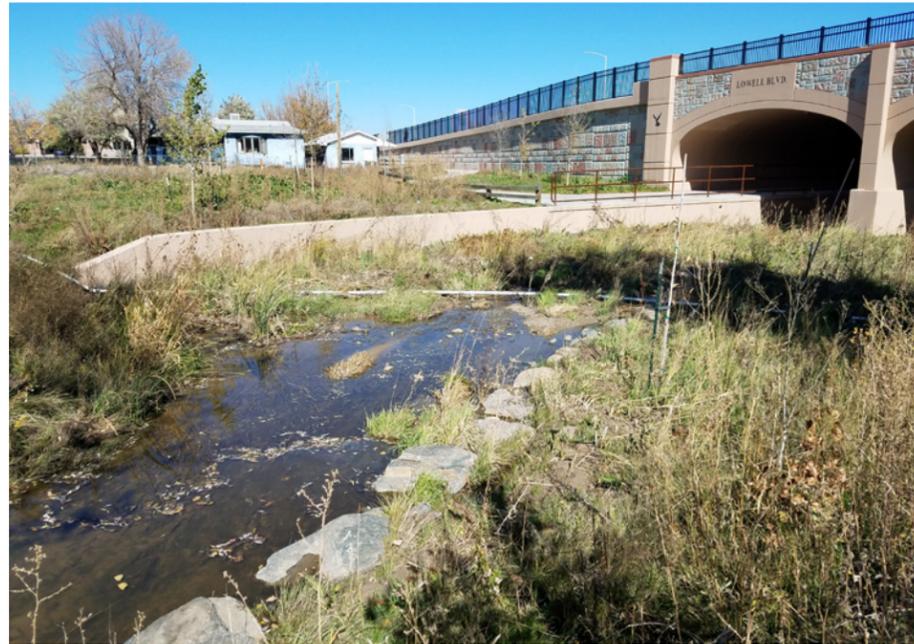
**Image 32** Looking northwest at section 6. The channel is wider and braided in this outwash section and connected the floodplain on the south (right) side.
