# **Nissen Reservoir Channel** *Ecological Site Assessment*

**BROOMFIELD COUNTY, COLORADO**

**DHM DESIGN**

**October  
2017**

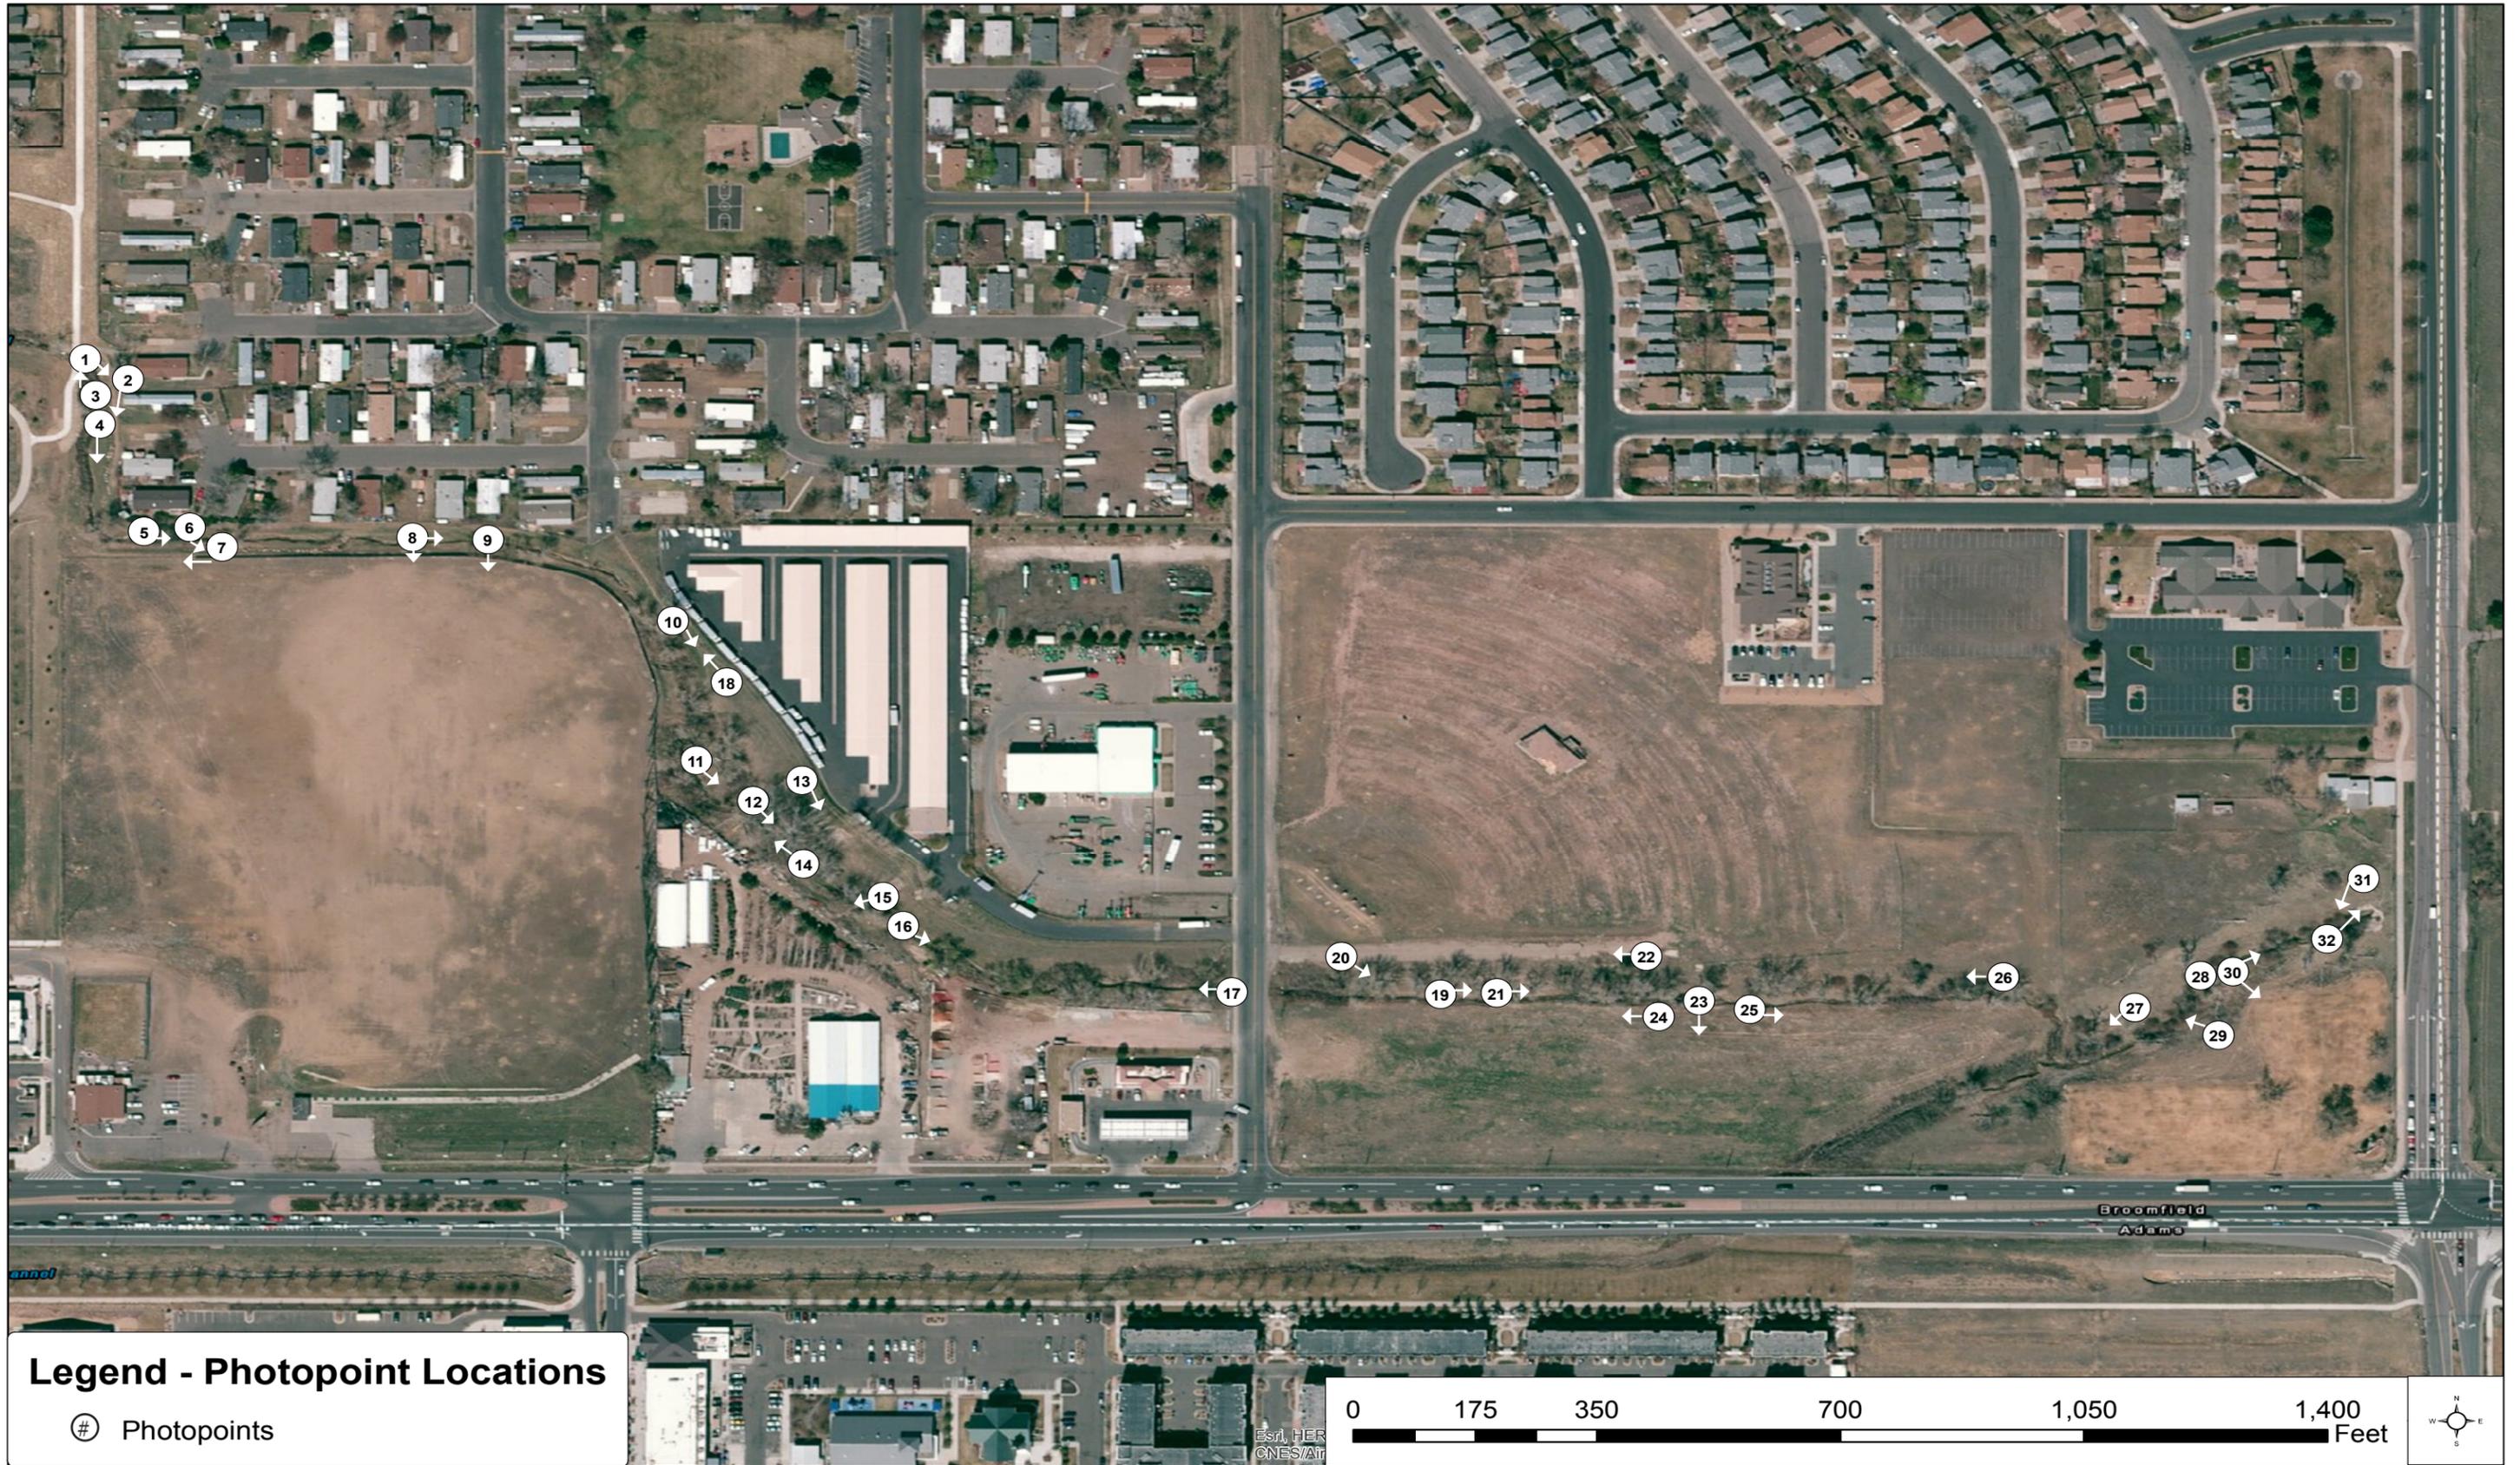
**Image 1** Looking southeast at the stream channel in moderately functioning section 1. Algae is covering the rocks in the stream. Coyote willow, showy milkweed, and soft-stem bulrush are present.
